# **Muography for Structural Health Monitoring of Hydraulic Dams: A Field Experiment on a Reservoir Auxiliary Dam**

**Muographers 2026 Budapest**

## Mangshan Reservoir Auxiliary Dam

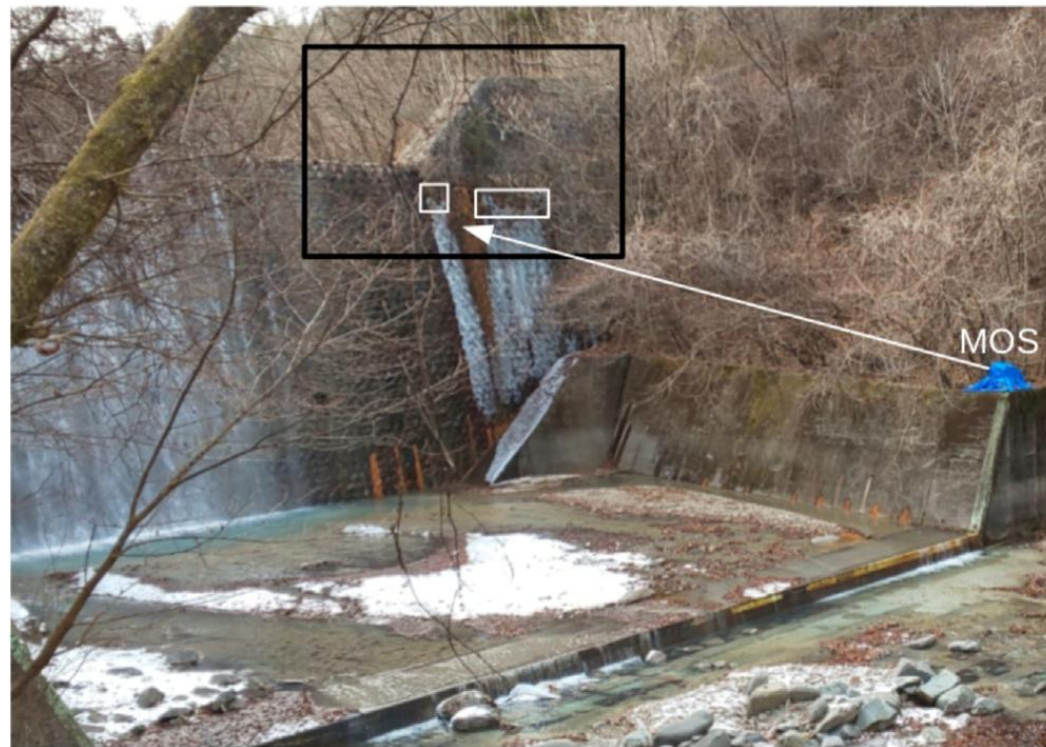
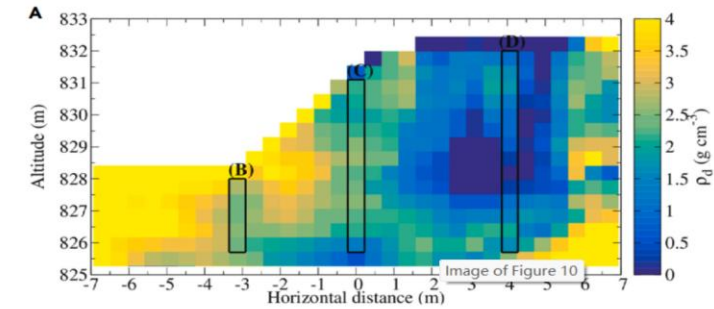
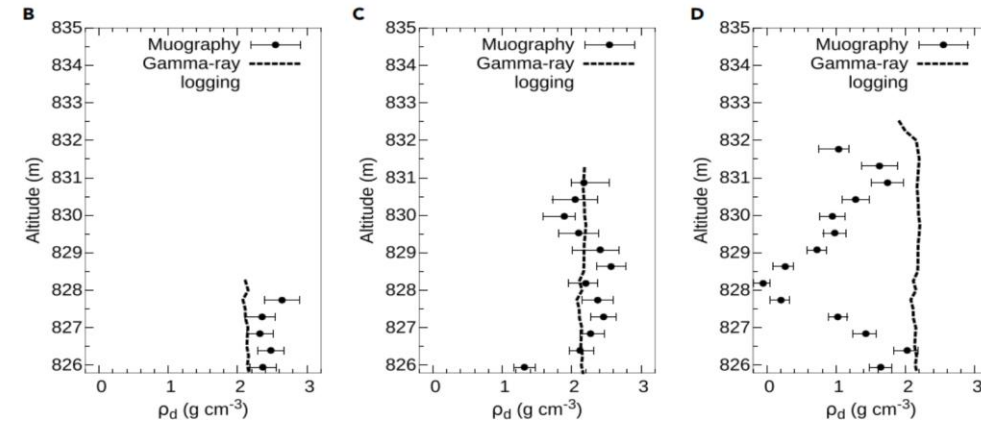
## ➤ Karasu River Sabo Dam, Gunma Prefecture, Japan

Cement loss was observed in the downstream section of the dam (highlighted by the white boxed area).

- Non-uniform density distribution detected within the dam
- High consistency with gamma-ray logging results

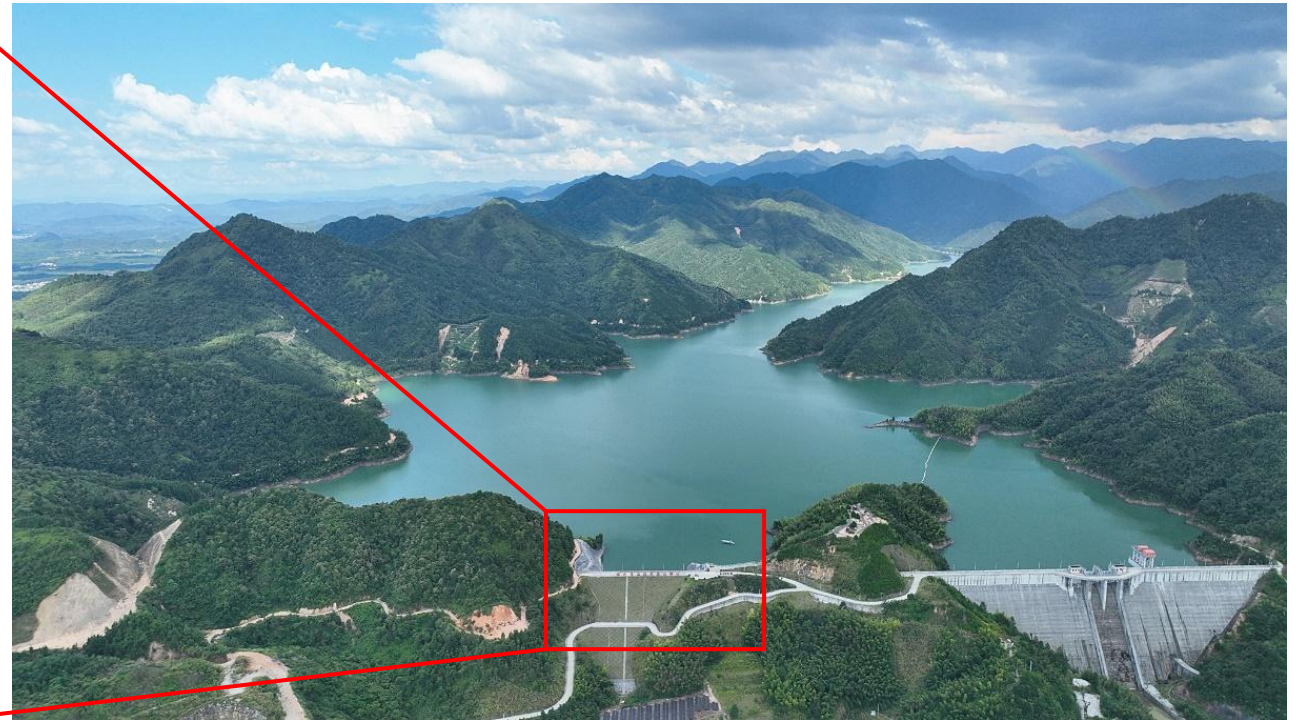
Potential seepage hazards at the dam–hillside interface.

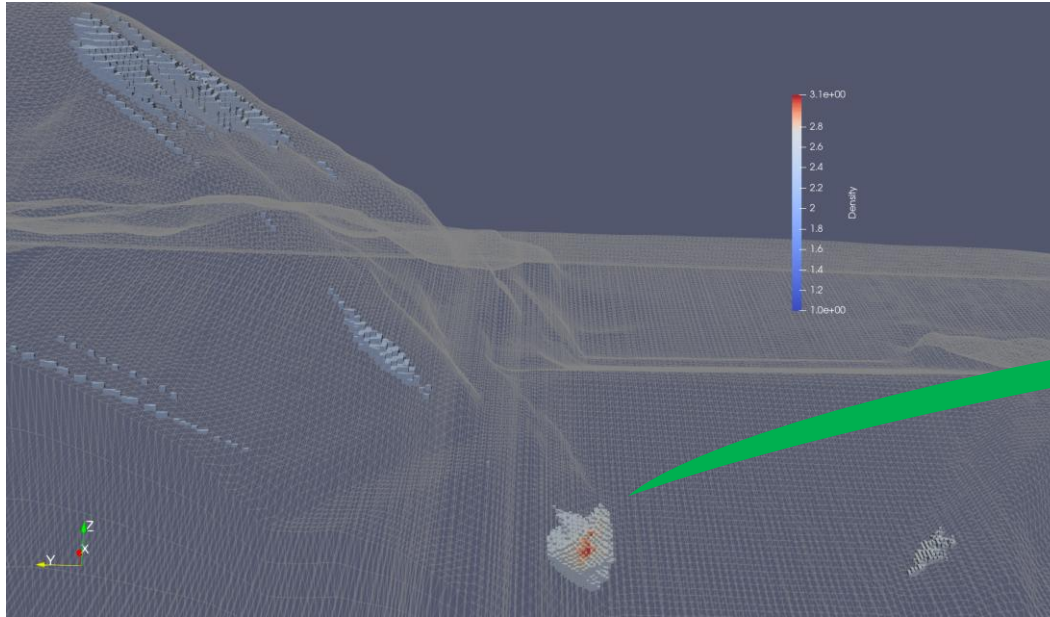
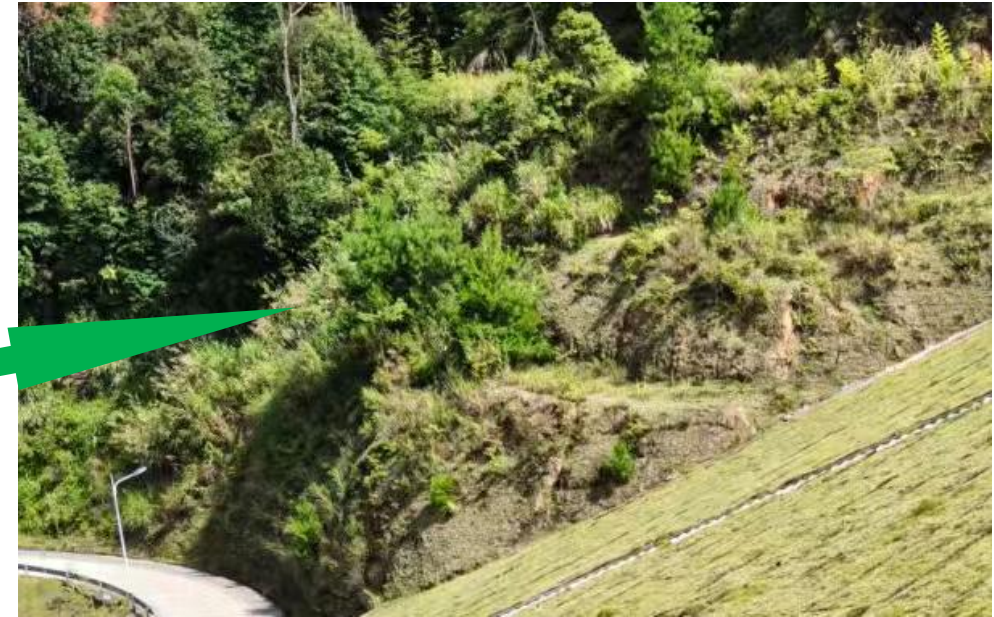
High-Density Regions in the Inversion Results

- A high-density anomaly was detected. The anomalous region appears to be associated with an artificial structure. Further review of construction records may help determine whether additional reinforcement was applied during dam construction.

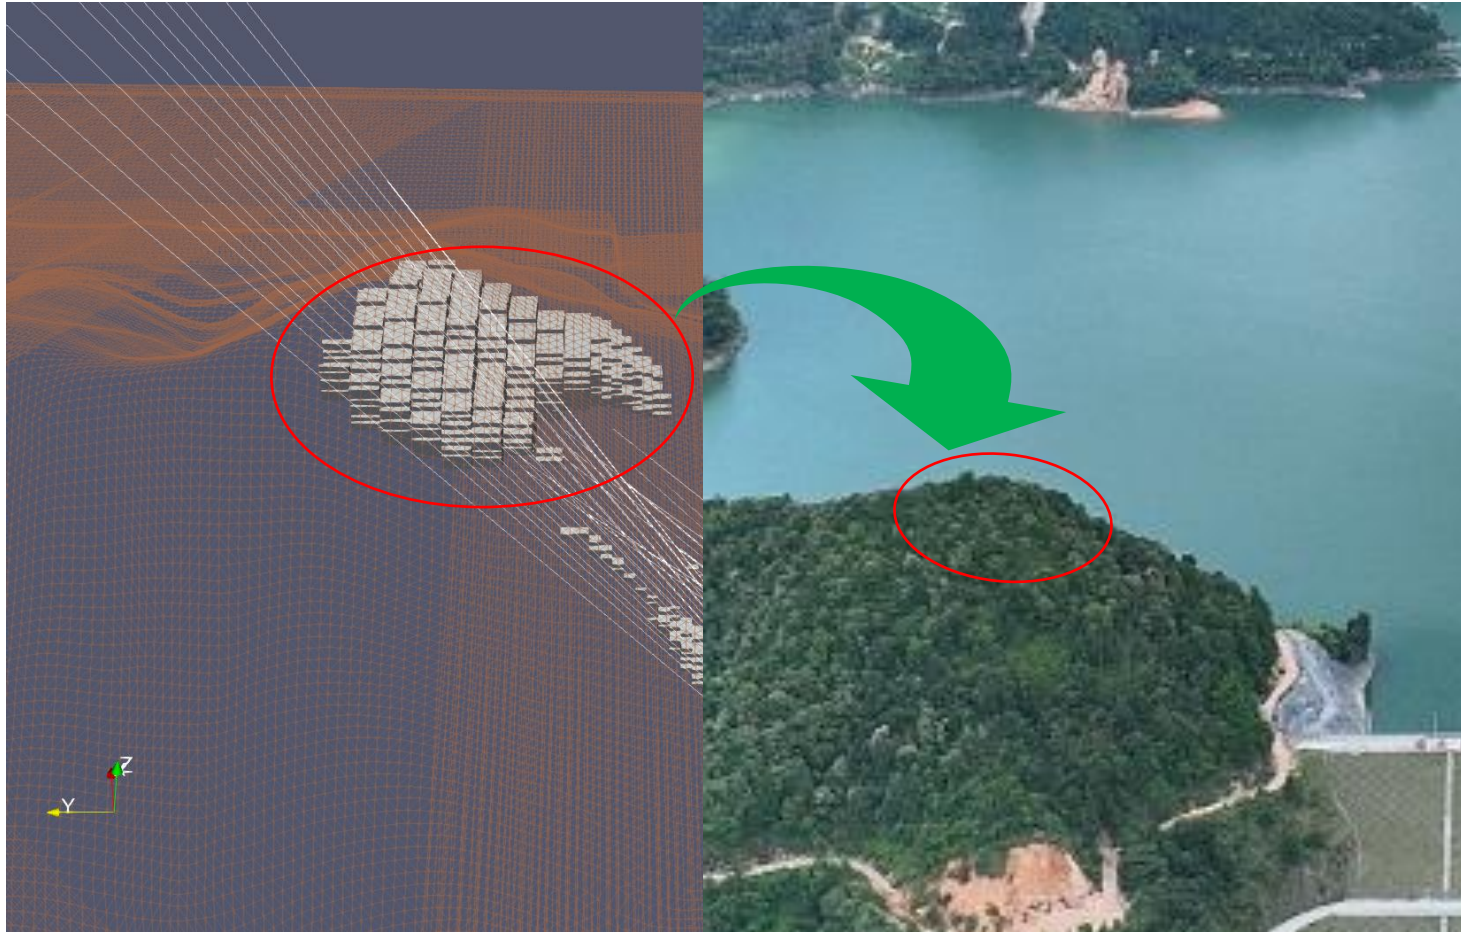
Low-density anomaly detected at the top of the northern hillside

Density contrast:  $> 0.25 \text{ g/cm}^3$

Depth: 5–10 m

N–S extent:  $\sim 40 \text{ m}$

E–W extent:  $\sim 20 \text{ m}$

- **Dynamic monitoring can be implemented during the rainy season if necessary**
- **To investigate seepage, crack propagation, and other common hazards**
